MERRIMACK RIVER BASIN
FRAMINGHAM, MASSACHUSETTS

RESERVOIR NO 2 DAM
MA 00338

PHASE I INSPECTION REPORT
NATIONAL DAM INSPECTION PROGRAM

JULY, 1981

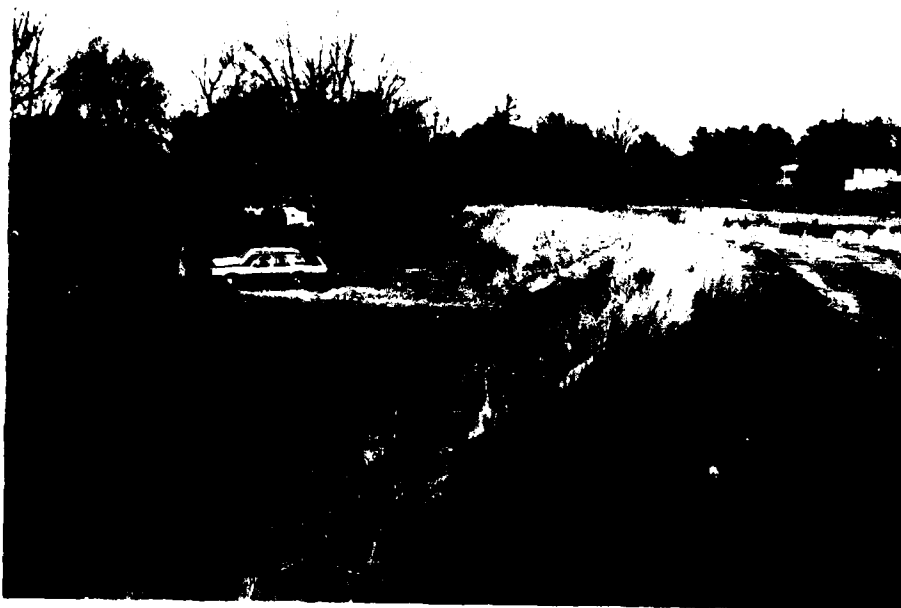
Photo No. 8 - Downstream slope of dam viewed
from gatehouse.

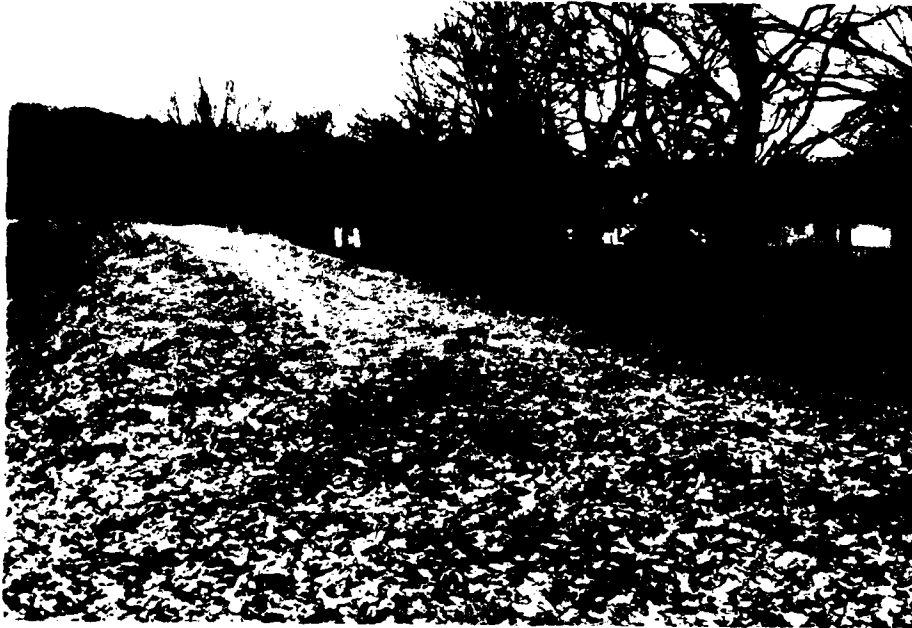
Embankment section between spillway and right abutment - The crest of this portion of the embankment is not paved and has a sparse cover of grass which appears to have been mowed. There are wheel tracks on the crest (Photo No. 3). Riprap on the upstream slope extends from an elevation a few feet below the crest to an undetermined elevation below the level of the reservoir at the time of the inspection. The riprap is in good condition (Photo No. 4). Between the top of the riprap and the crest is a sparse cover of unmowed weeds and grass and a very small amount of brush. Unmowed grass and weeds cover the downstream slope, except that there is riprap on the bottom of the slope from a few feet above tailwater level to an undetermined elevation below tailwater level in the deeper section of the valley near the spillway. Next to the gatehouse, which is at the right end of the stone-masonry spillway, the crest, upstream slope (Photo No. 5), and downstream slope (Photo Nos. 6 and 7) are severely eroded. The area downstream of the embankment (Photo No. 8) is well maintained and shows no signs of seepage. The right abutment consists of soil and is in good condition. There is a row of large maple trees about 20 feet downstream of the toe of the dam, but they are not considered a potential problem because of the low height of the embankment and the distance from the toe (Photo No. 8).

- (3) Wheel tracks and inadequate vegetation on the crest of the embankment between the spillway and right abutment render the embankment susceptible to erosion and possible breaching if it should be overtopped.

Photo No. 3 - Top of right embankment.

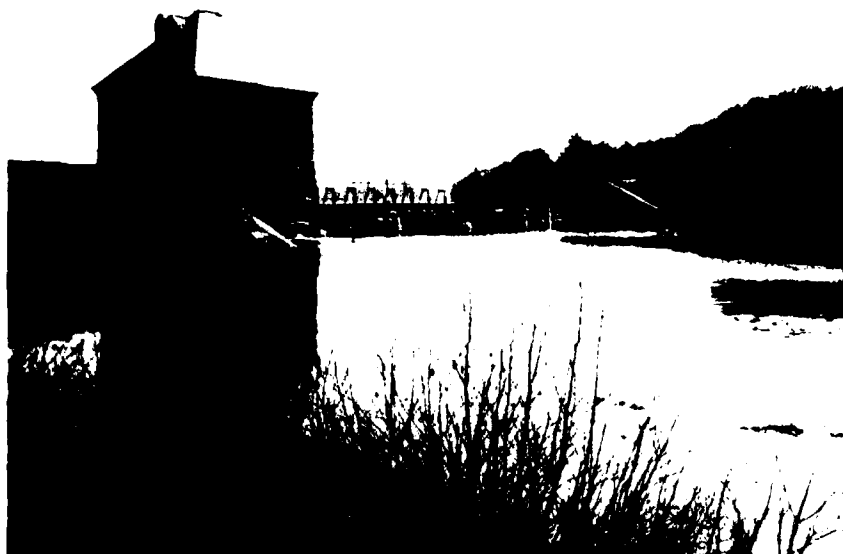
Photo No. 2 - Gatehouse, spillway and downstream
faces of embankments.

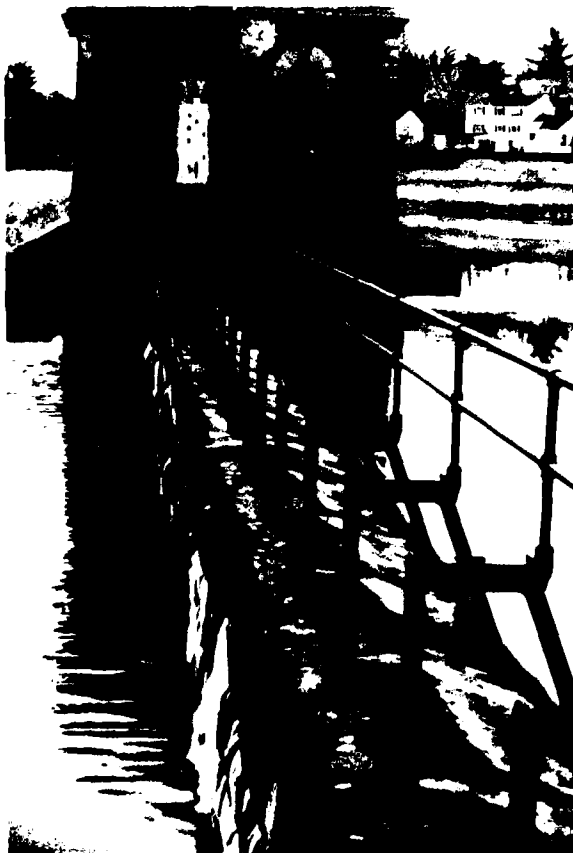
Photo No. 10 - Downstream side of granite spillway.
